Technical Guide

Guide to Assessment and Repair of Flood Damaged Timber and Timber Framed Houses

(Revised Feb 2022)

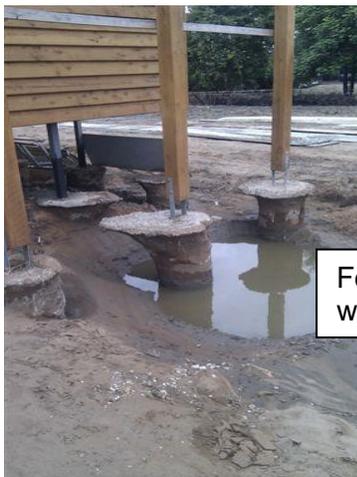
Footings scoured out by fast flowing water

Failure to address or correct these types of faults could severely affect the future structural performance of the building.

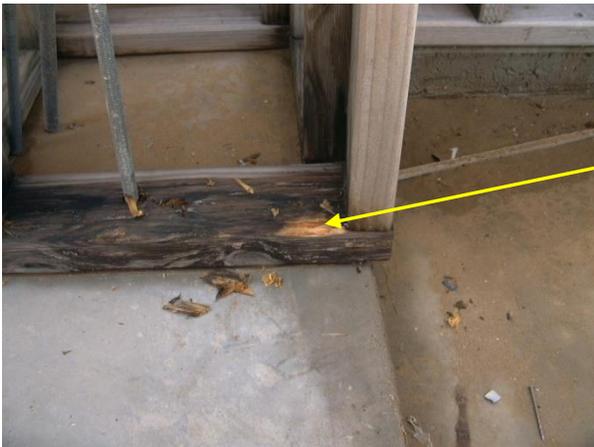
Although heavily discoloured with surface mould and blue stain, the pine timber is still sound as shown by scraping back the surface layer

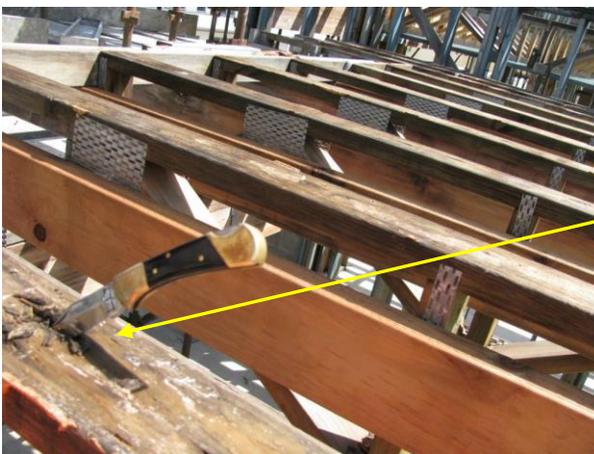
Decayed timber is soft and spongy and can easily be penetrated with a knife or screwdriver

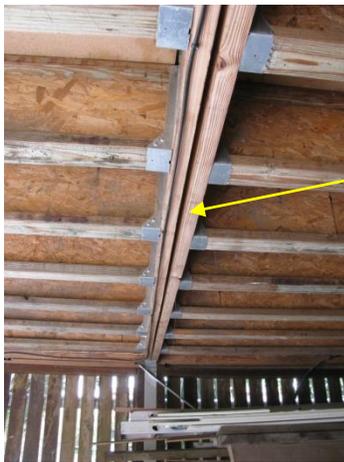
Expansion of the hardwood T&G floor above has caused the separation of double bearers.

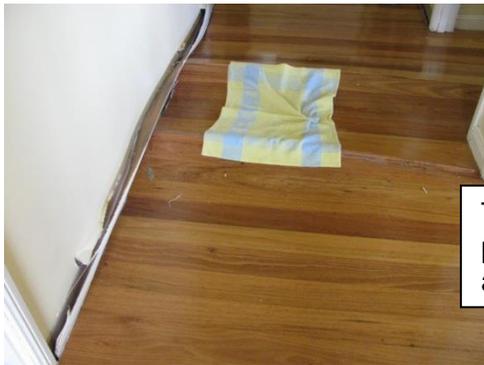
This inundated T&G floor over particleboard tented about 1 week after the water receded.

Allow the flooring a minimum of 4 months to dry out before re-assessing. Gaps between boards are highly likely to occur as the floor dries out, however the structural adequacy of the flooring is not likely to have been compromised and floors may be lived on in the meantime.
